# Complete transmural gastric migration of PTFE mesh after surgery for a recurrent hiatal hernia

Transmural gastric migration, PTFE, Hiatal hernia.

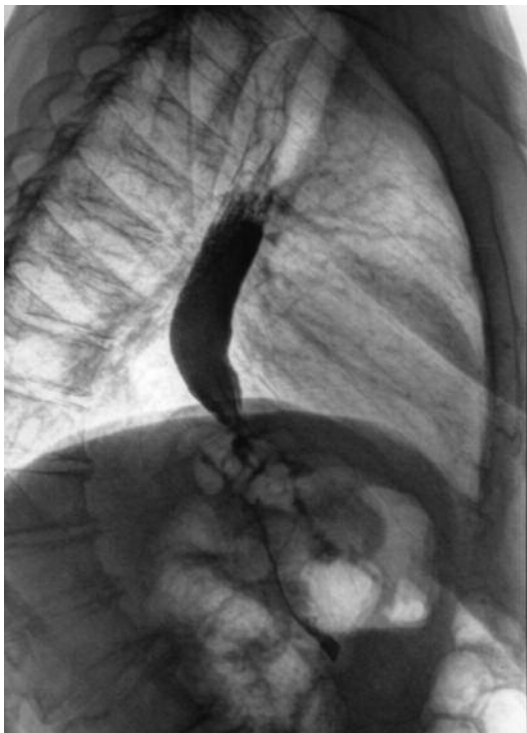
**Figure 1.** Barium swallow examination: anomalous esophago-gastric transit and hiatal stenosis.

A 47-year-old woman came to our attention for a subacute onset of severe dysphagia and weight loss. She previously underwent laparoscopic Nissen fundoplication with cruroplasty for a large recurrent hiatal hernia. During last surgical procedure, a “dog-shaped” expanded polytetrafluoroethylene (PTFE) dual mesh was placed. With the clinical suspicion of “Tight Nissen”, a barium swallow examination was performed and the anomalous esophago-gastric transit was confirmed (Figure 1). Endoscopy revealed a circular stenosis in the lower esophagus, a rotation of the

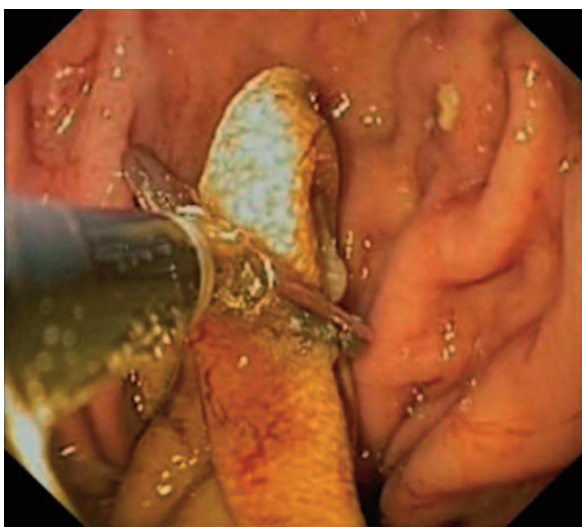
**Figure 2.** Endoscopic finding of the foreign body: the PTFE Mesh appears as a whitish shrunken material free-moving in the gastric lumen.

stomach (with the greater curvature completely revolved in anterior position) and, surprisingly, the presence of PTFE-Mesh, identified as a whitish shrunken material, free-moving in the gastric lumen (Figure 2). No mucosal lesions were seen. With the use of rat-tooth forceps, the foreign body was removed (Figure 3) without any complications (see video-clip). After few days, only a partial improvement was obtained. Thus, the patient underwent a surgical debridement of hiatal scar tissue and a gastropexy procedure (greater curvature fixed to the abdominal wall). 6 months after surgery, the patient is almost symptomless as remarked by barium swallow examination (Figure 4).

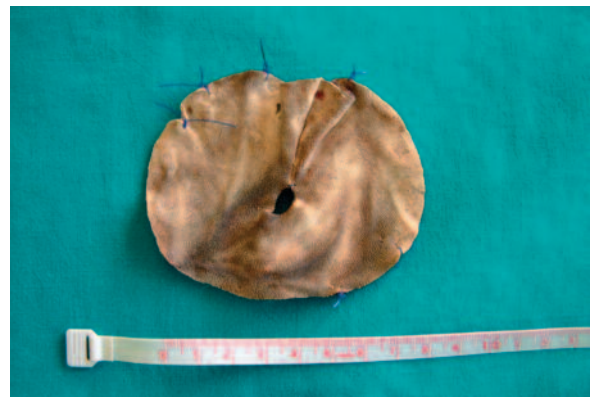
**Figure 3.** The PTFE Mesh after the removal.

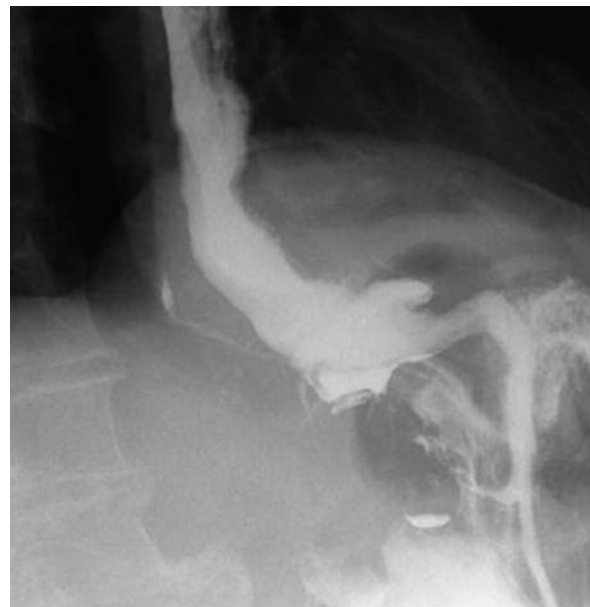
**Figure 4.** Barium swallow examination (performed 6 months after surgery) showing normalized esophago-gastric transit.
